FIELD INSPECTION REPORT

Project Name:	Mountain Valley Pipeline	Inspector:	Matthew Grant							
Inspection Date:	Tuesday, August 11, 2020	Project Contact:	Brian Clauto							
Spread G: Giles	AR-GI 245.01 , 249, 249.03 MP 209.4- 211 ATWS 1366, 1367, 1369	Weather:	Dry							
ACTIVE STAGE OF CONSTRUCTION: (Check all that apply)

FIELD INSPECTION PHOTO LOG

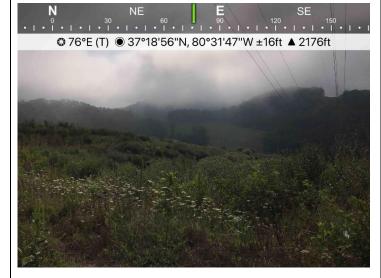
Figure 4: Near MP 210 area is dormant and stabilized
